Preview - SDA_113217Source Language ▼**Question**

Mandatory: Leaking water from the blowdown valve of Exprelia.

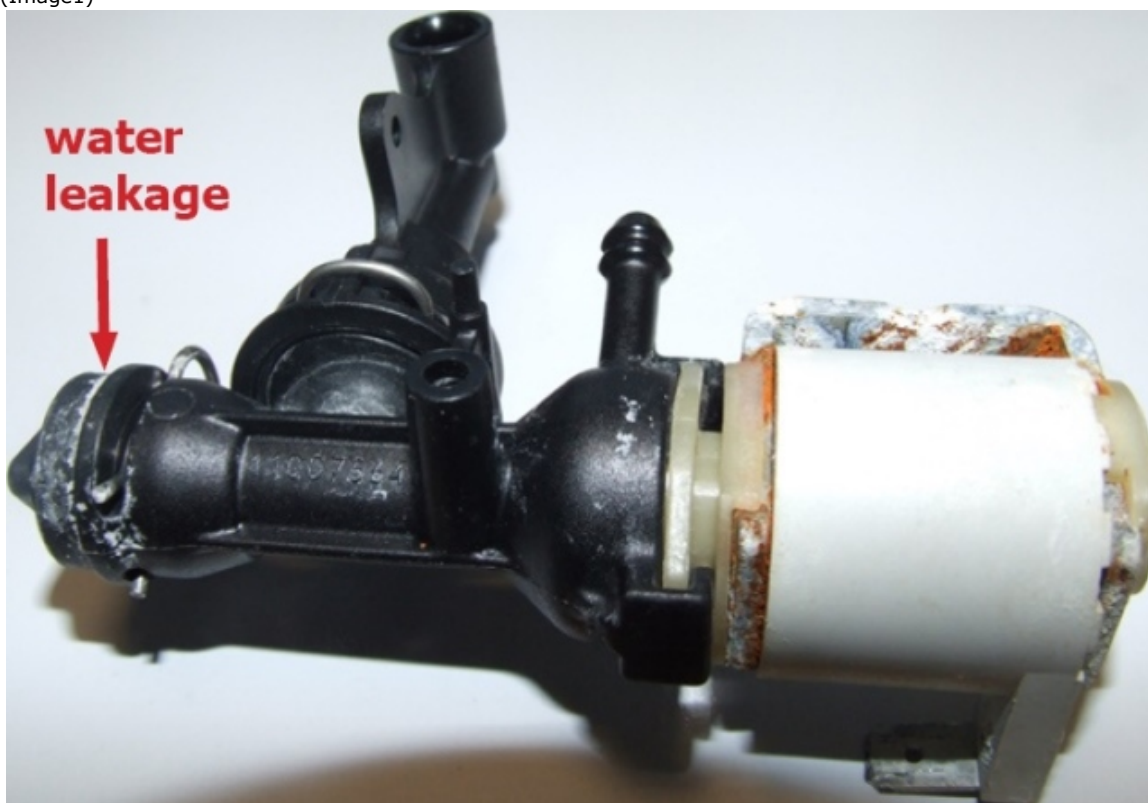
It could happen that from the blowdown valve in Exprelia there is a water leakage. (Image1)

**CURE:**In all machines Exprelia produced **up to. WK10 2015 mandatory** replace the:**421944039871 BLOWDOWN VALVE V3 MYB9 230V ASSY.****421944039911 BLOWDOWN VALVE V3 MYB9 120V ASSY.****421944039921 BLOWDOWN VALVE V3 MYB9 100V ASSY.****421944039931 BLOWDOWN VALVE V3 MYB9 220V-60HZ ASSY.**

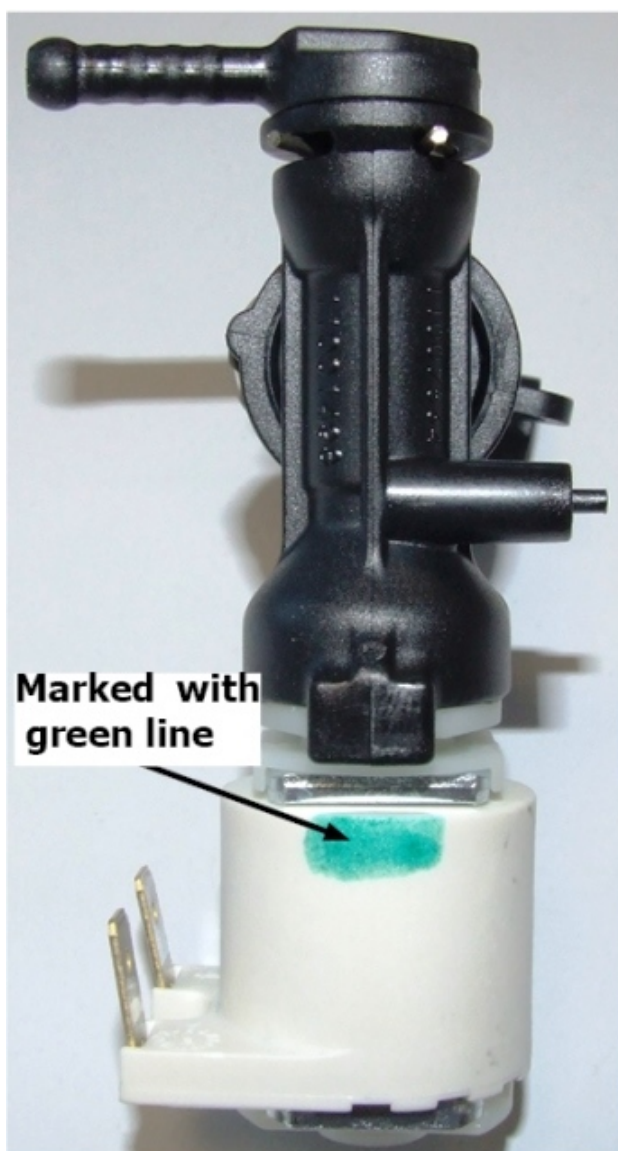
The valve will be delivered with a green line to make it recognizable. (Image2) to avoid replacement on repeat repairs.

Do not use cannibalized parts from other machine.
