Service Bulletin

MODEL: FDR-AX53.

No. E58409851

Subject: Cannot record / play back 4K movie

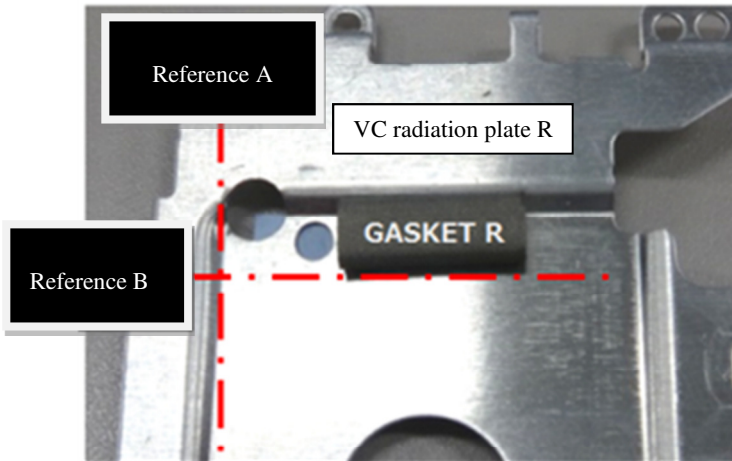
- Attachment of sheet(0826)F to VC radiation sheet R

Contact of the lens block or the tripod block to the VC Board may damage the solder portion of the IC.

- Reference A: Alignment with the left end of the hole of VC radiation plate R
- Reference B: Alignment with the bottom end of GASKET R
